Privileged and Confidential
Prepared at the Request of Consul
Alaska Pacific Powder Site
Mark Johns
December 20, 1994

The following information pertains to photographs taken by Mark Johns while on a site visit to Pacific Powder Site on December 20, 1994. The text is annotated with references specific items detailed in the letter dated August 5, 1994, from Mark Johns to Mr. James Ragen.

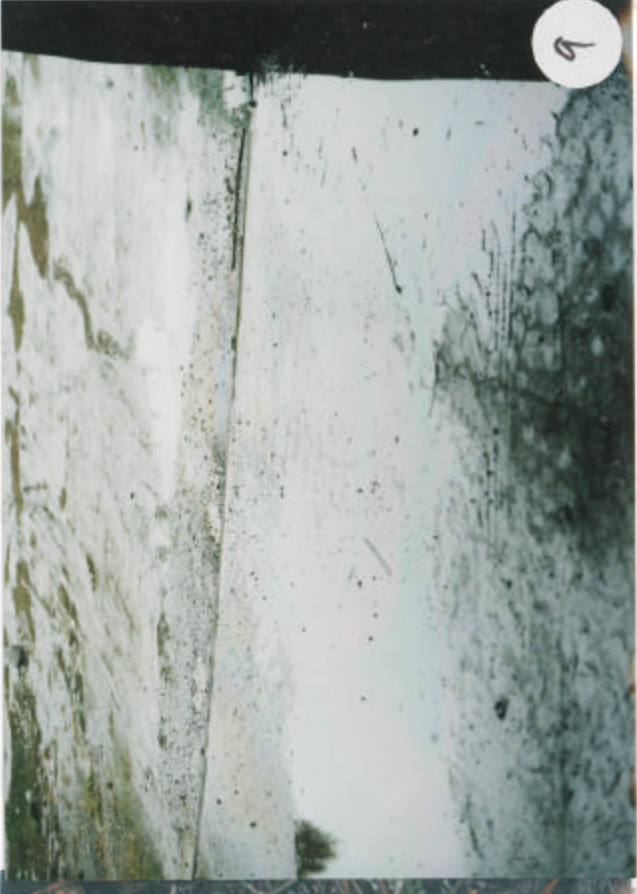
9

(7)	Inside dipping plant, no additional work has been performed.
(8)	Corrugated garage south of dipping plant with electrical boxes.
(9)	Oil sheen on main garage floor.
